A.J. CLARK SCHOOL OF ENGINEERING  
Civil & Environmental Engineering Department

## HYATT REGENCY HOTEL IN KANSAS CITY COLLAPSE – A CASE STUDY

*2017 Project Management Symposium*

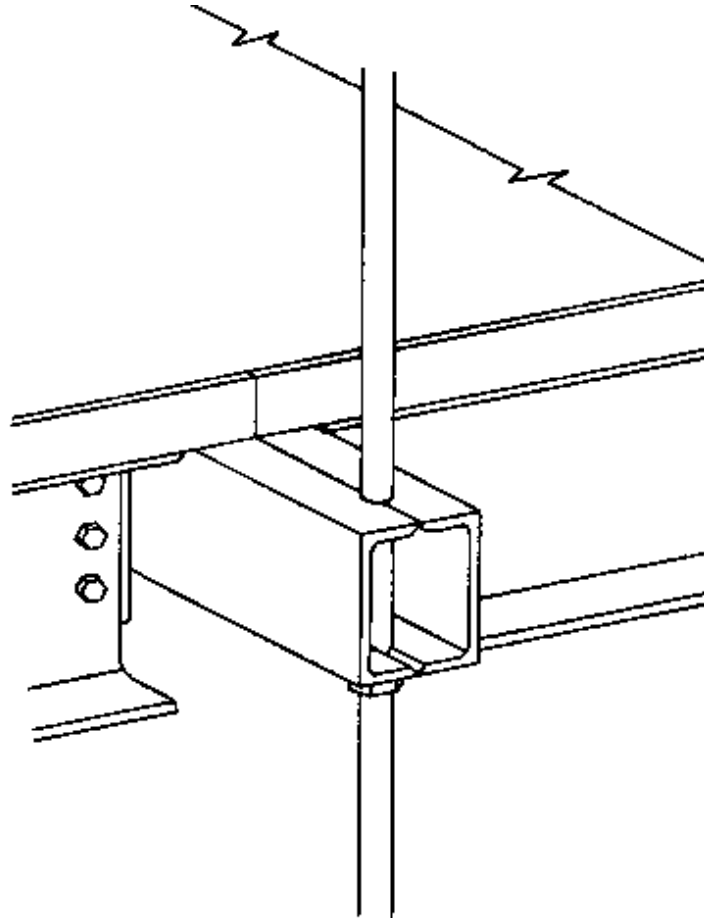
## Walkway as Designed

- The hotel's design called for walkways to span the atrium at the second and fourth floors.
- The original design specified continuous hanger rods run from the ceiling through the fourth-floor beams and on through to the second-floor beams.

Box beams of 4<sup>th</sup> floor walkway was designed to carry only the 4<sup>th</sup> floor load

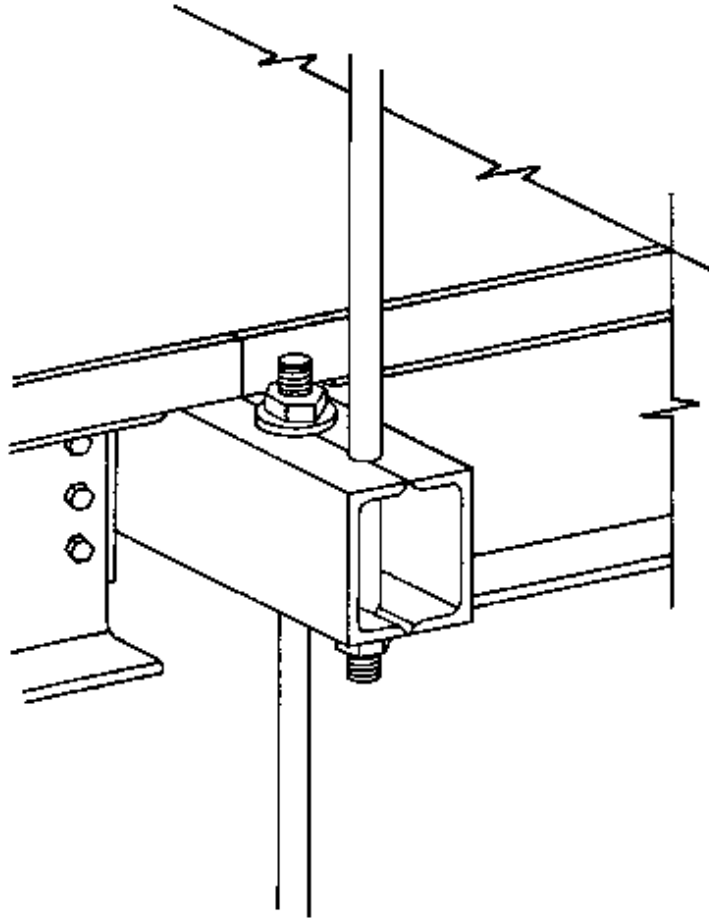
## Walkway as Built

- During the course of construction, design shop drawings prepared by the steel fabricator suggested that a set of two hanger rods replace the single hanger rod between the second and fourth-floor walkways.
- This change doubled the load.
- The design shop drawings were stamped by the architect, structural engineer, and contractor indicating their review.

Box beam of 4<sup>th</sup> floor carried the 4th floor load and the 2<sup>nd</sup> floor load

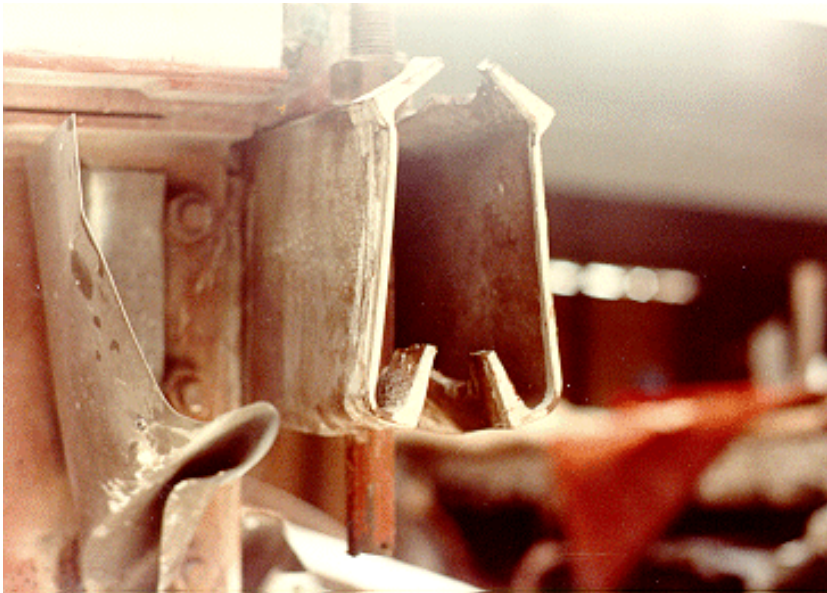
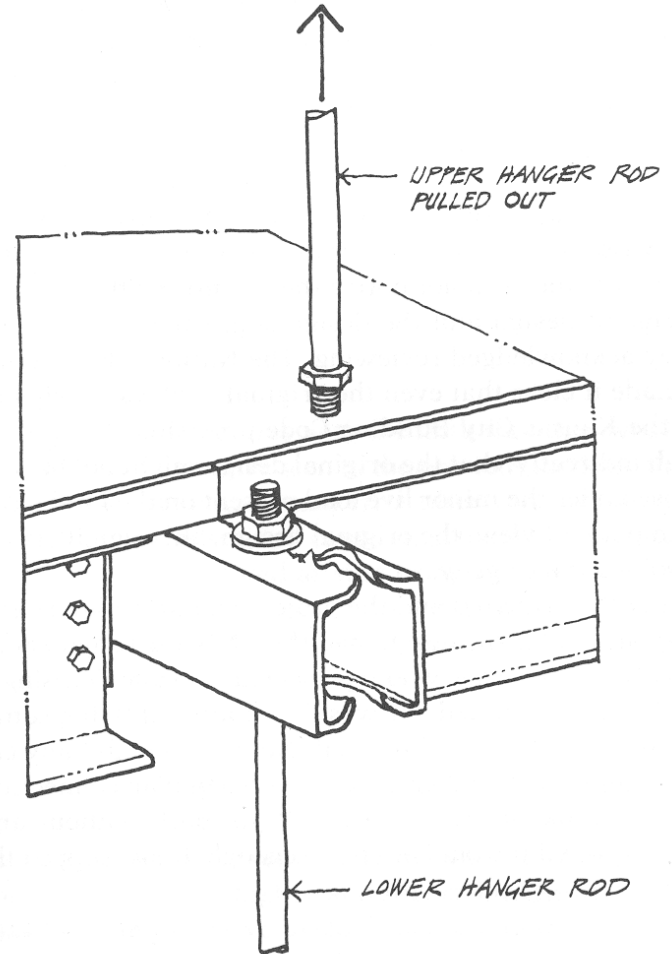
Pulled-Out Rod at Fourth-Floor Box Beam

# The Upper Rod Pulled out @ the 4<sup>th</sup> floor box beam

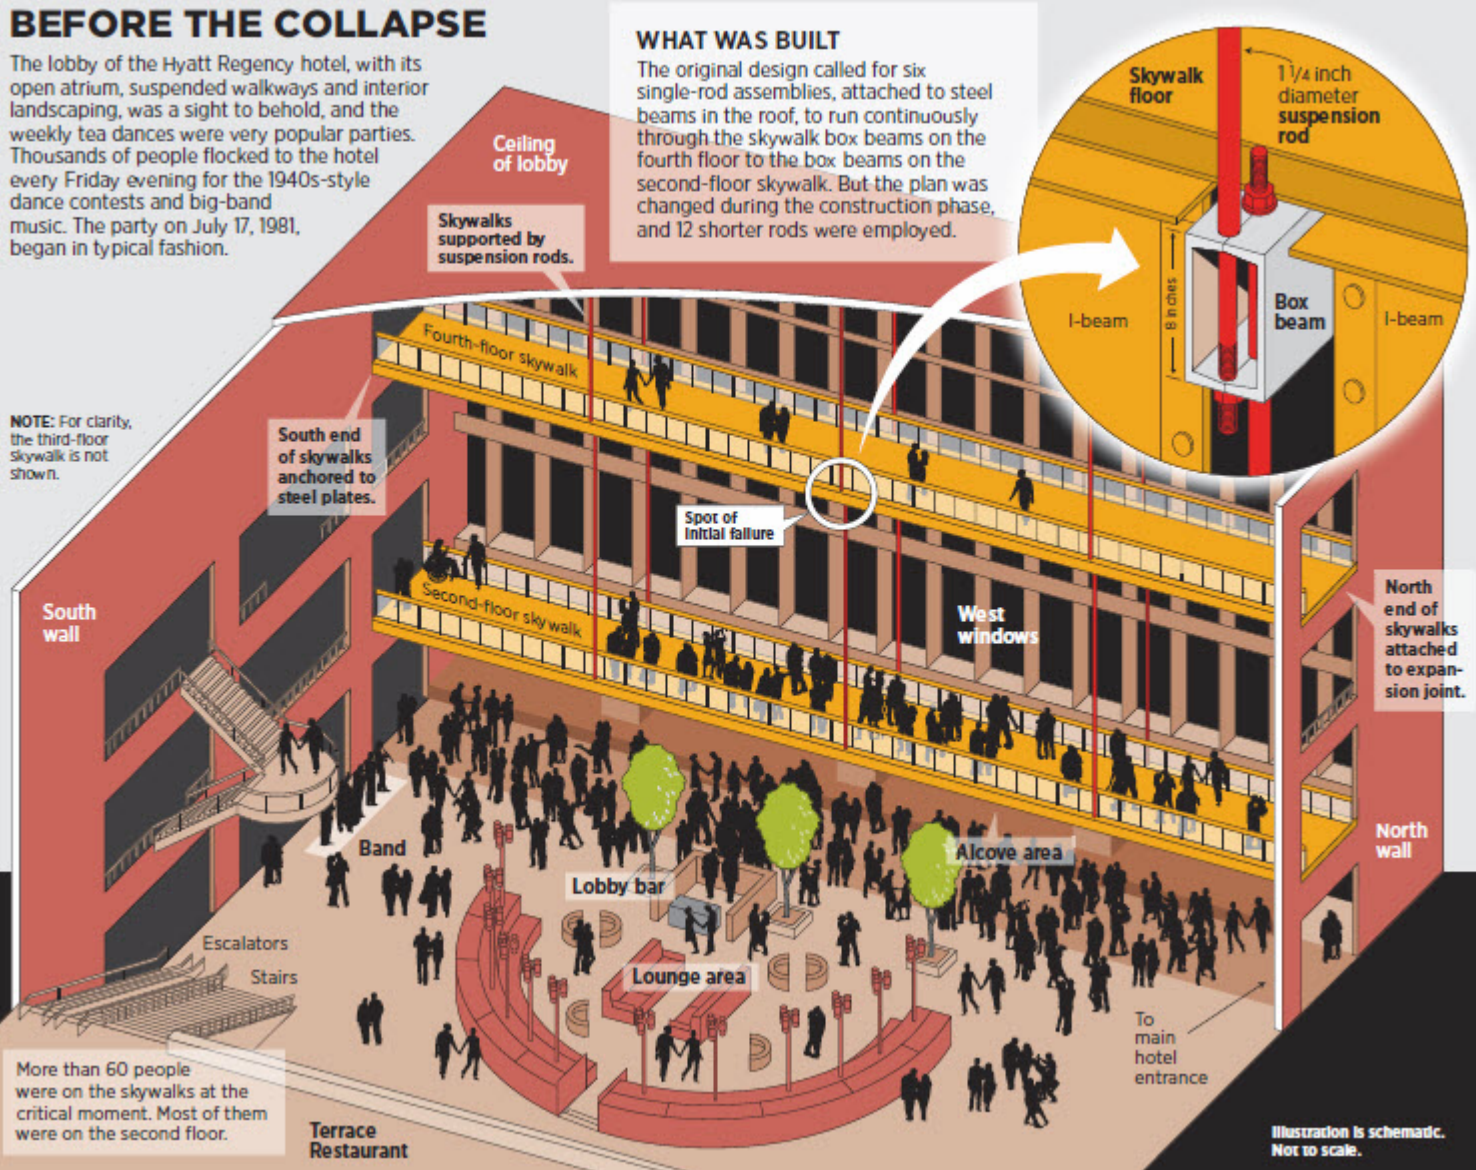
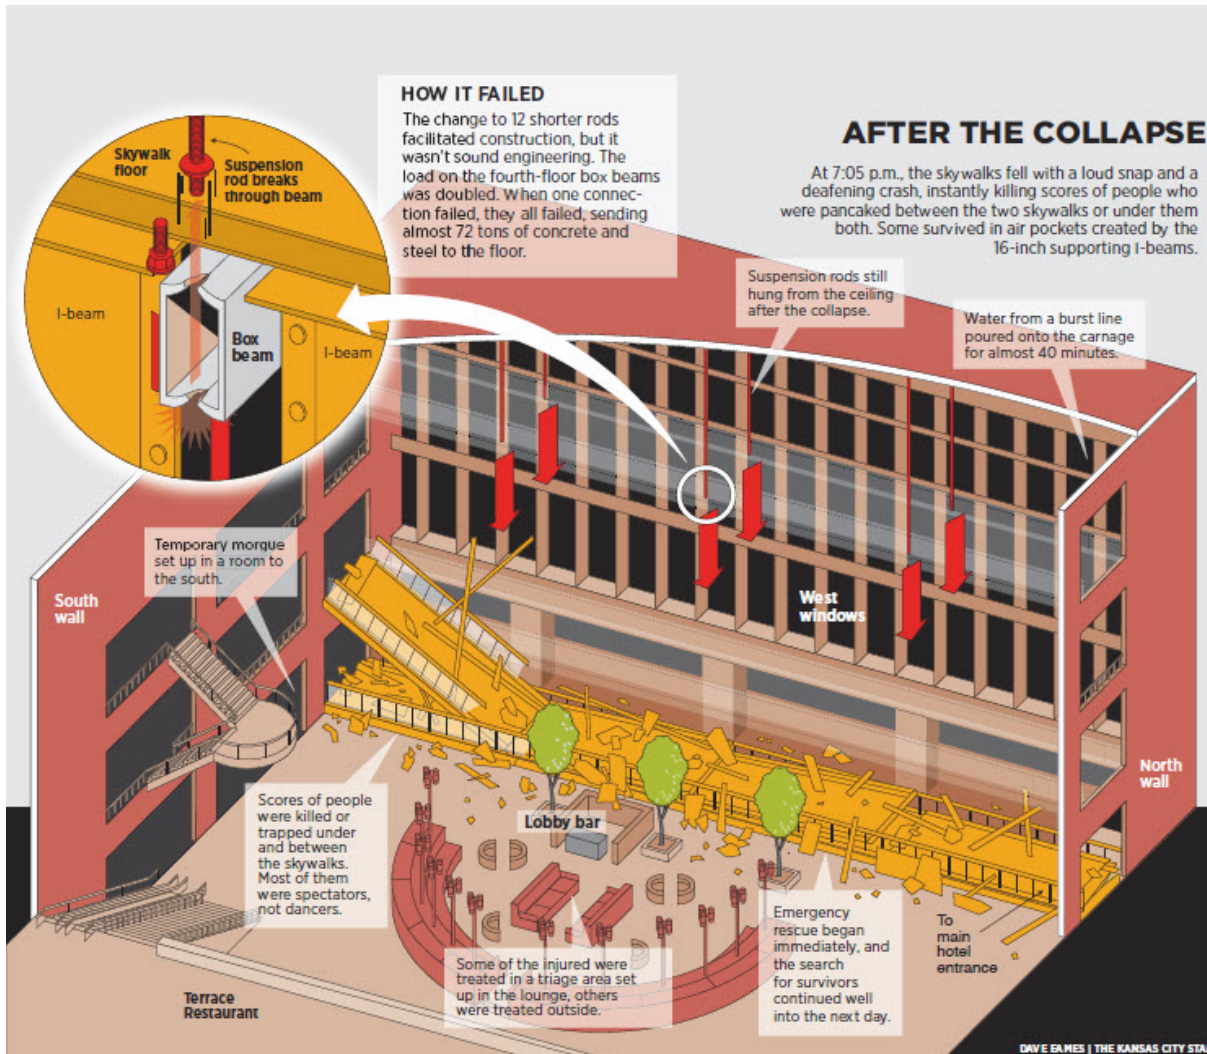
**NOTE:** For clarity, the third-floor skywalk is not shown.

**HOW IT FAILED**  
The change to 12 shorter rods facilitated construction, but it wasn't sound engineering. The load on the fourth-floor box beams was doubled. When one connection failed, they all failed, sending almost 72 tons of concrete and steel to the floor.

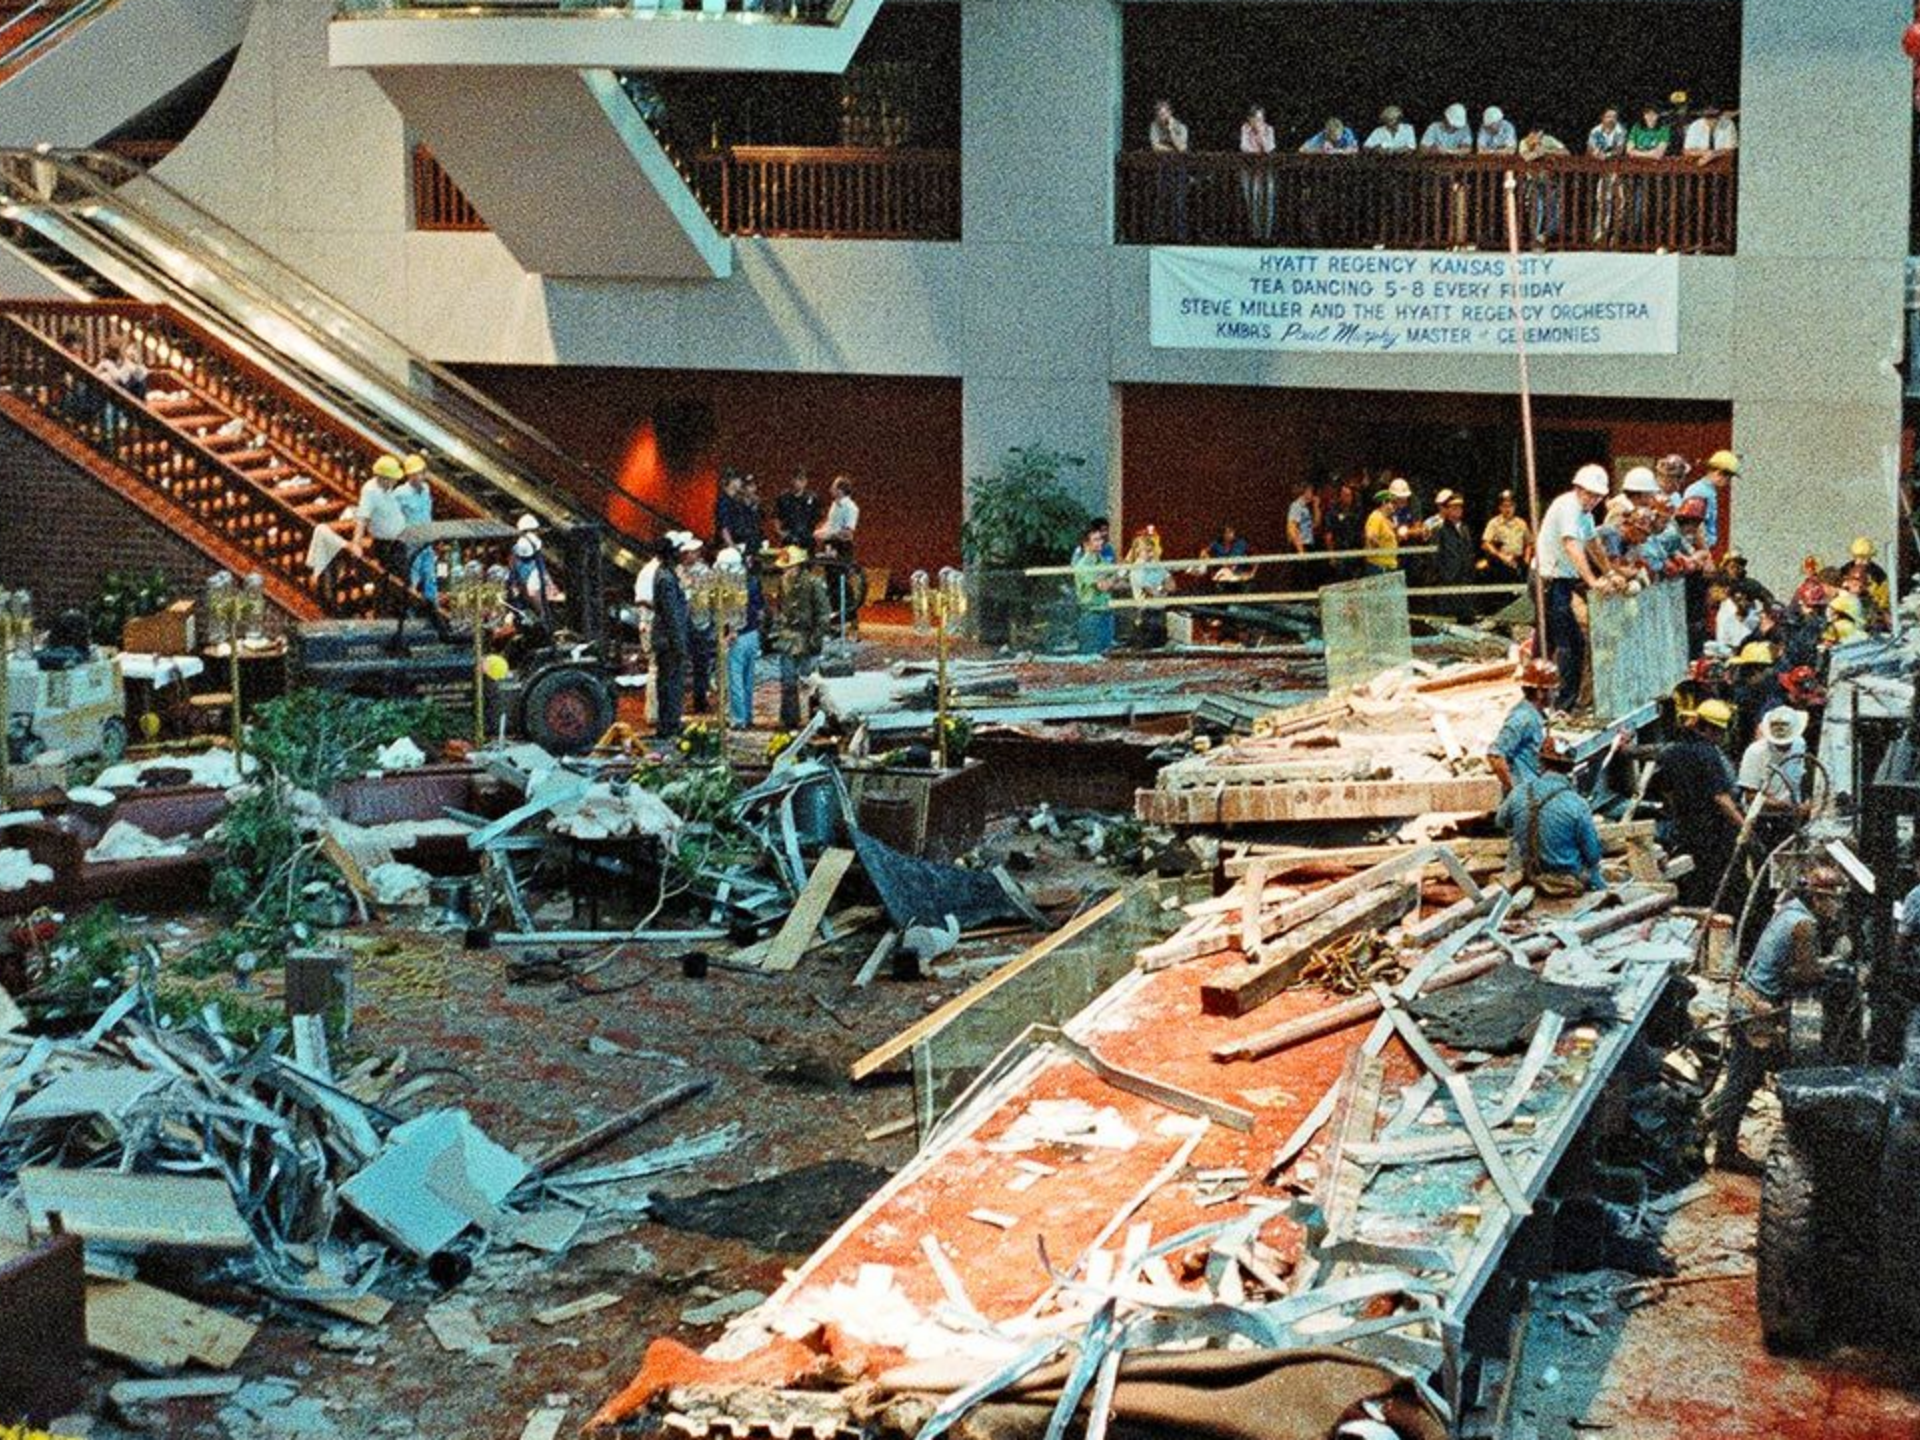
At 7:05 p.m., the skywalks fell with a loud snap and a deafening crash, instantly killing scores of people who were pancaked between the two skywalks or under them both. Some survived in air pockets created by the 16-inch supporting i-beams.

Suspension rods still hung from the ceiling after the collapse.

Water from a burst line poured onto the carnage for almost 40 minutes.

Scores of people were killed or trapped under and between the skywalks. Most of them were spectators, not dancers.
