CASE STUDY: DECK REPLACEMENT OF THE CHESAPEAKE BAY BRIDGE

Kenneth J. O'Connell, Ph.D., P.E., PSP, CFCC
Jennifer V. Tereyla, P.E., PSP, R.P.L.S.
2016 Project Management Symposium

This project involved the repair of a complex structural system on Maryland's Iconic Bay Bridge.

The Deck Replacement of the Westbound Through Cantilever Truss Span (Through Truss) portion of the Chesapeake Bay Bridge Project involved removal of the original cast-in-place concrete decking and replacing it with precast concrete sections, integrally cast with guardrail.

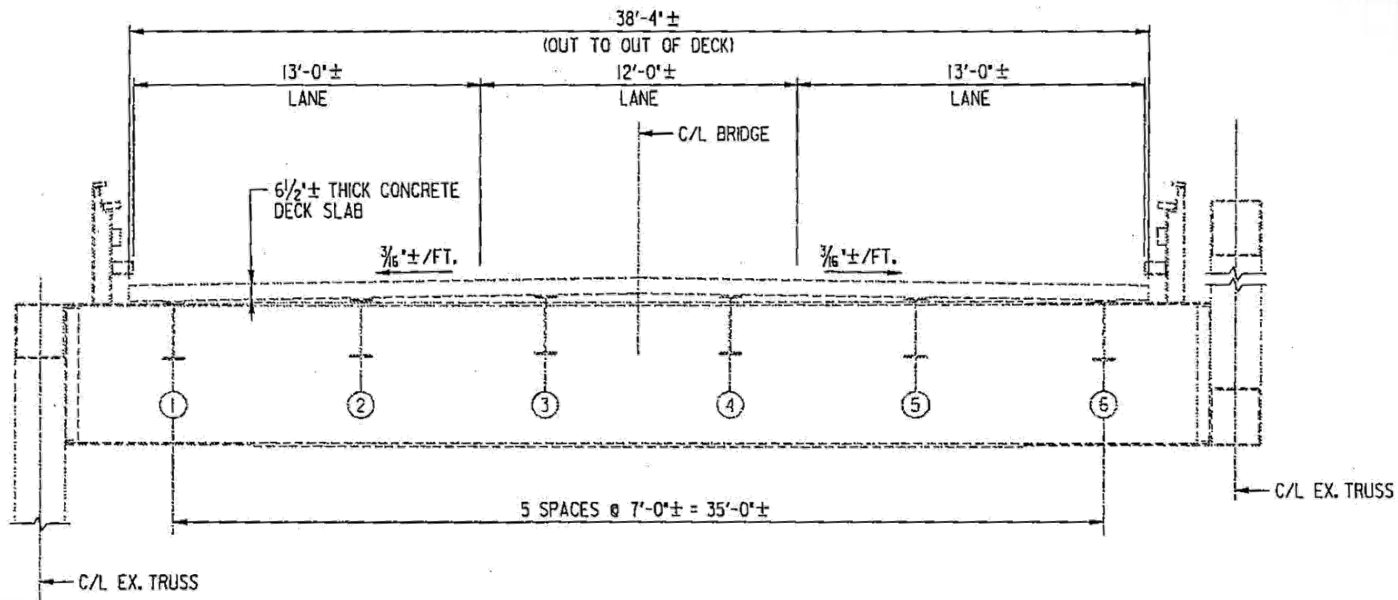
Existing Typical Section

EXISTING TYPICAL SECTION
SCALE: 1/4" = 1'-0"

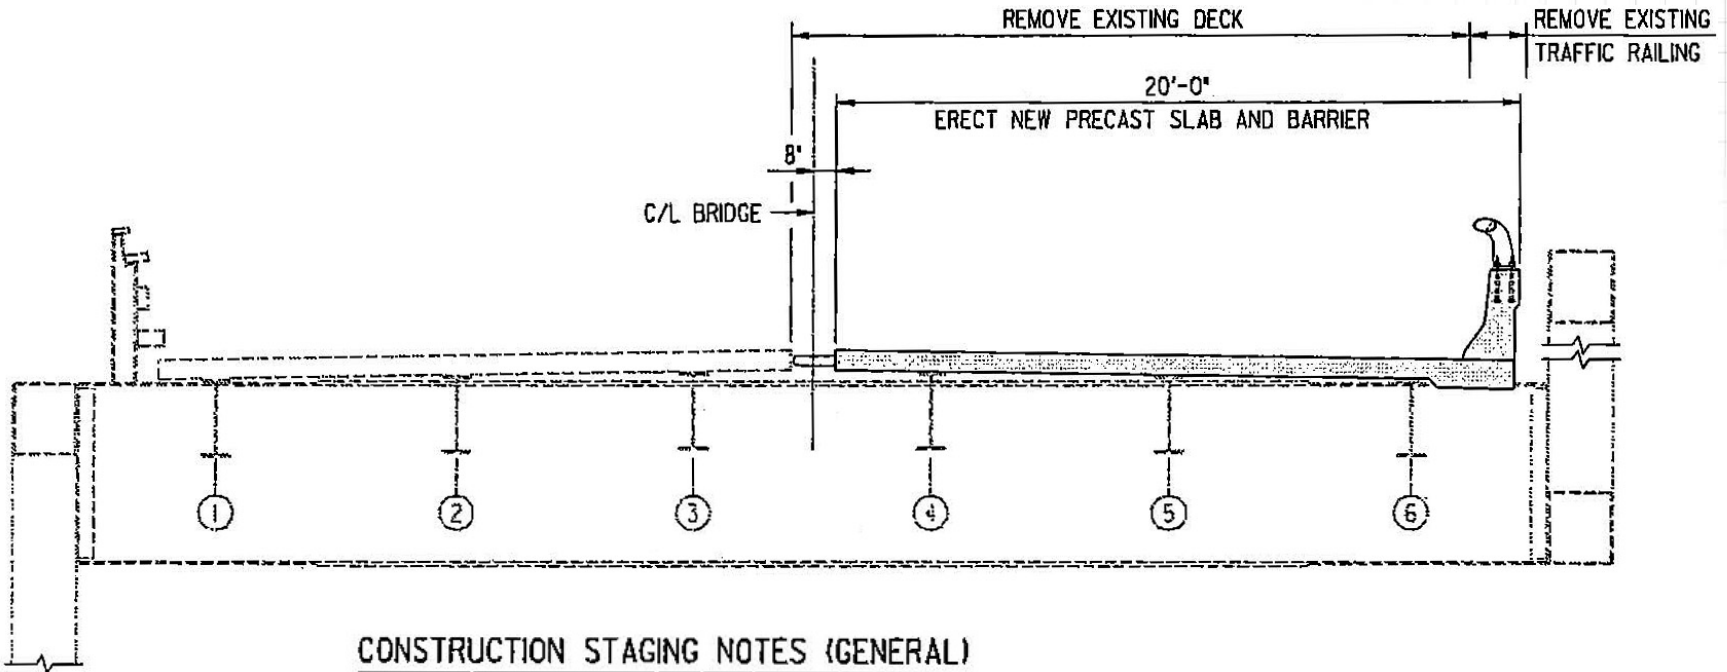
Phase 1

PHASE 1:

REMOVE REQUIRED SOUTH PORTION OF EXISTING DECK AND TRAFFIC RAILING. PLACE SOUTH PRECAST SLAB(S). COUPLE POST-TENSIONING BARS AND STRESS BARS TO REQUIRED LOAD. BOLT PRECAST SLABS TO EXISTING STRINGERS AND FILL BLOCKOUTS AND FLOOR BEAM/ STRINGER HAUNCH.

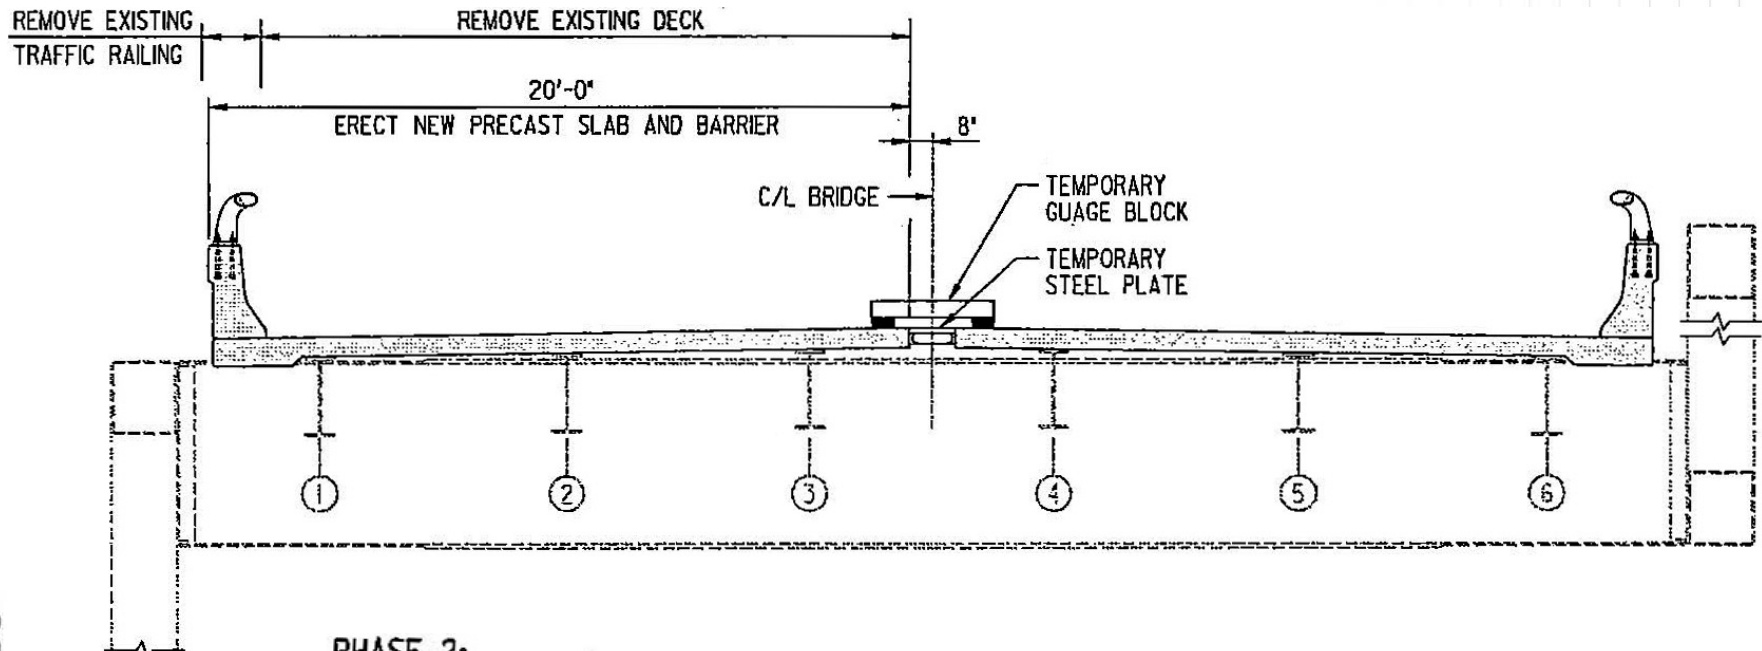
Phase 2

PHASE 2:

REMOVE REQUIRED NORTH PORTION OF EXISTING DECK AND TRAFFIC RAILING. PLACE NORTH PRECAST SLAB(S). COUPLE POST-TENSIONING BARS AND STRESS BARS TO REQUIRED LOAD. BOLT PRECAST SLABS TO EXISTING STRINGERS AND FILL BLOCKOUTS AND FLOOR BEAM/ STRINGER HAUNCH. INSTALL STEEL PLATE IN TRANSVERSE AND LONGITUDINAL OPENINGS. OPEN BRIDGE FOR THREE (3) LANES OF TRAFFIC (FOLLOWING MORNING).

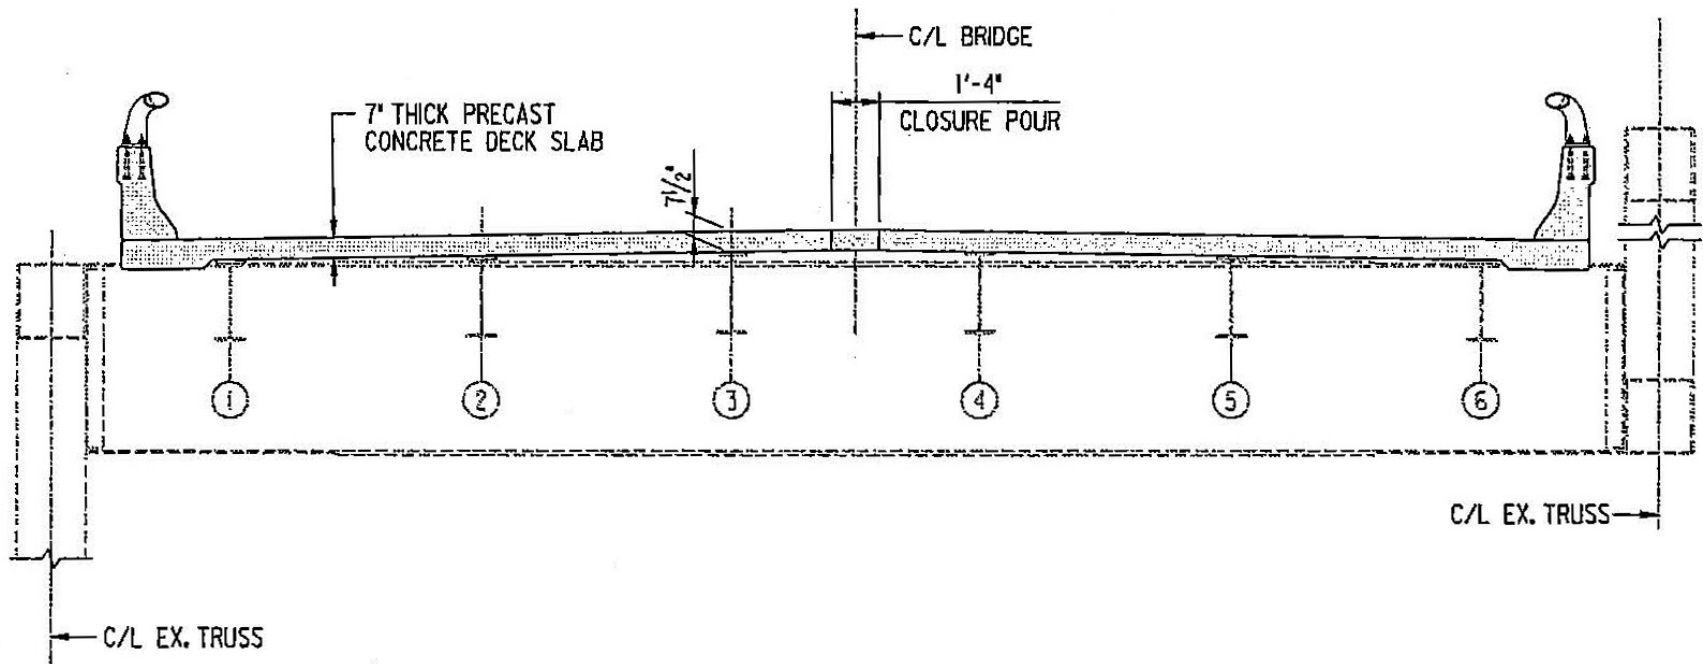
Phase 3

PHASE 3:

INSTALL AND STRESS STRAND TENDONS, GROUT ALL POST-TENSIONING DUCTS. CONSTRUCT CLOSURE POURS. CONTINUE OPERATION UNTIL REPLACEMENT OF PRECAST SLABS FOR THE THROUGH TRUSS SPANS IS COMPLETE.

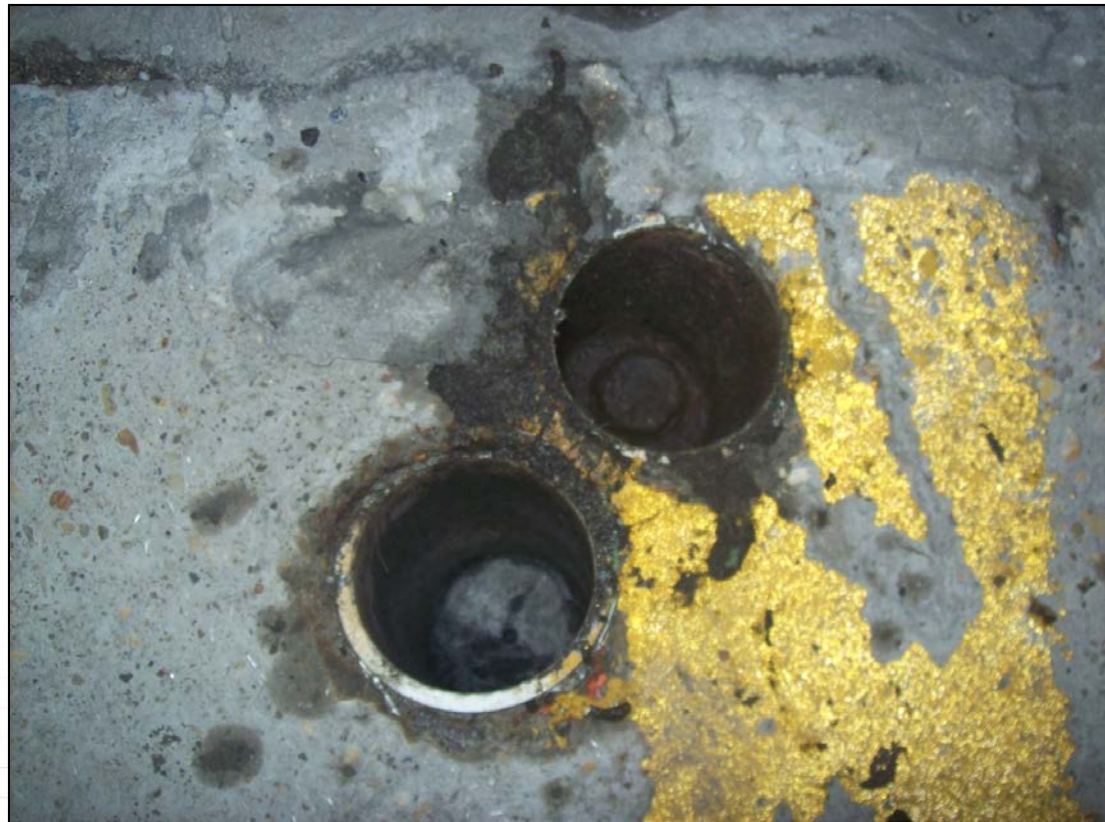
- Construction of Survey Pockets

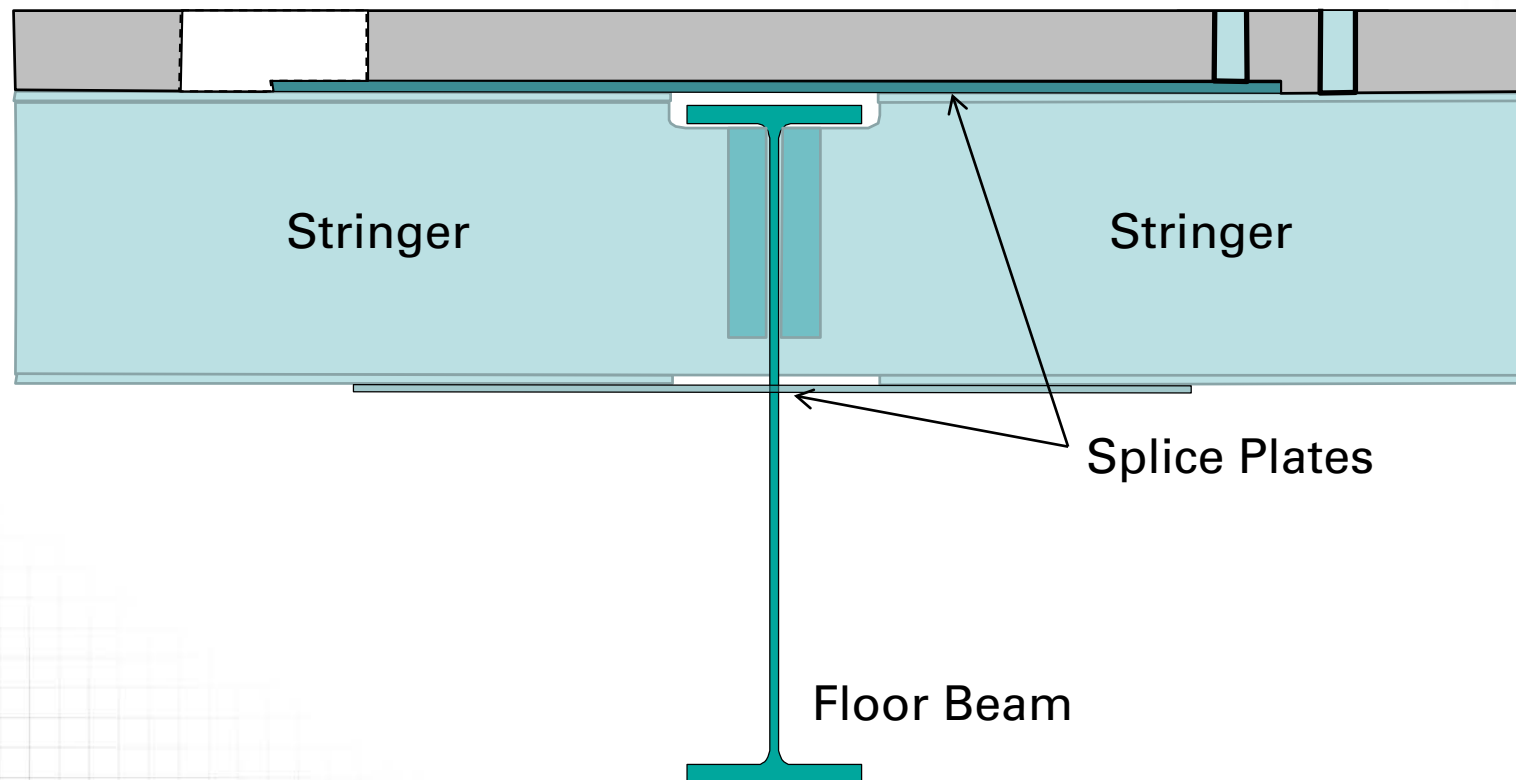
- Scope of Work - Construction of Survey Pockets

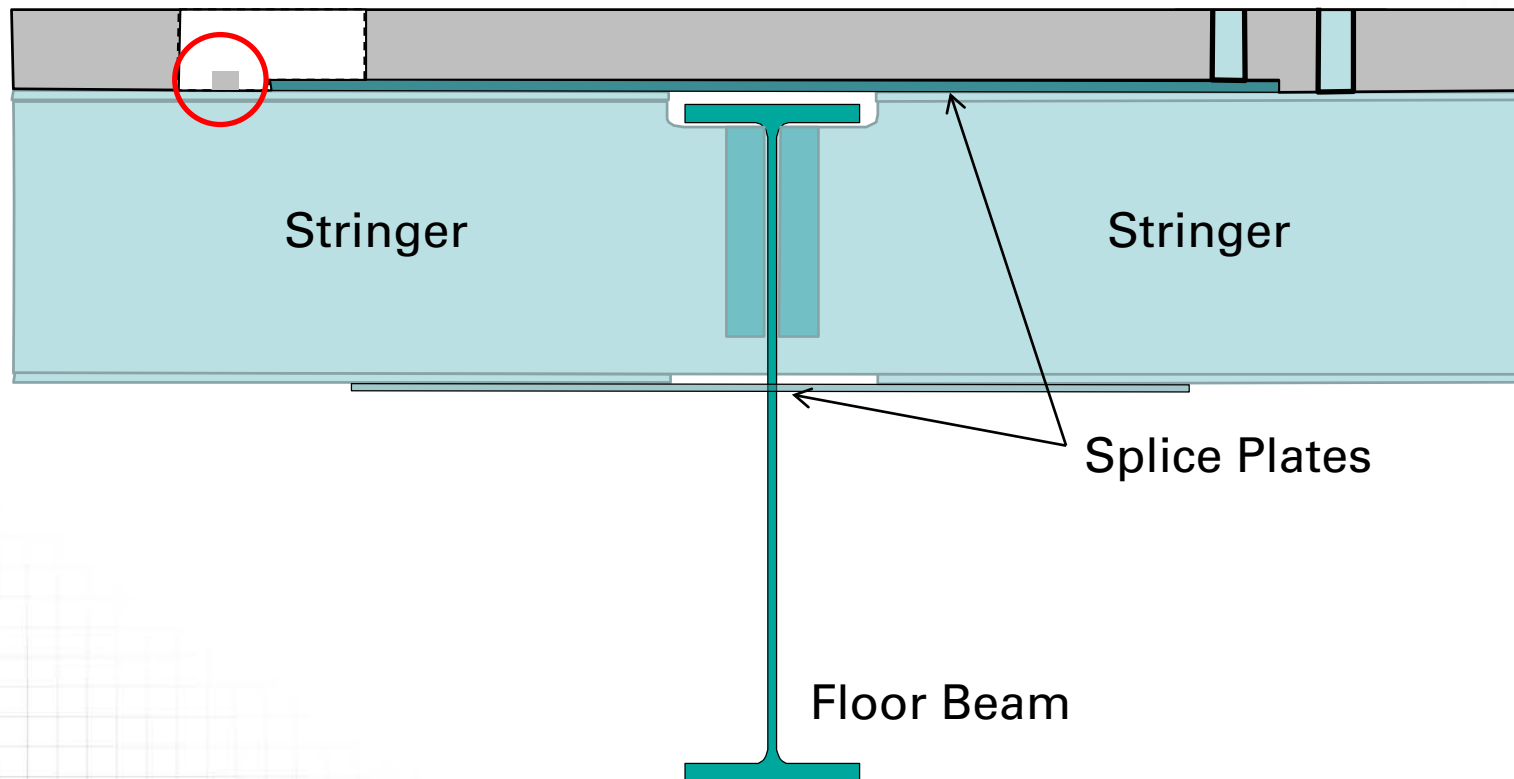
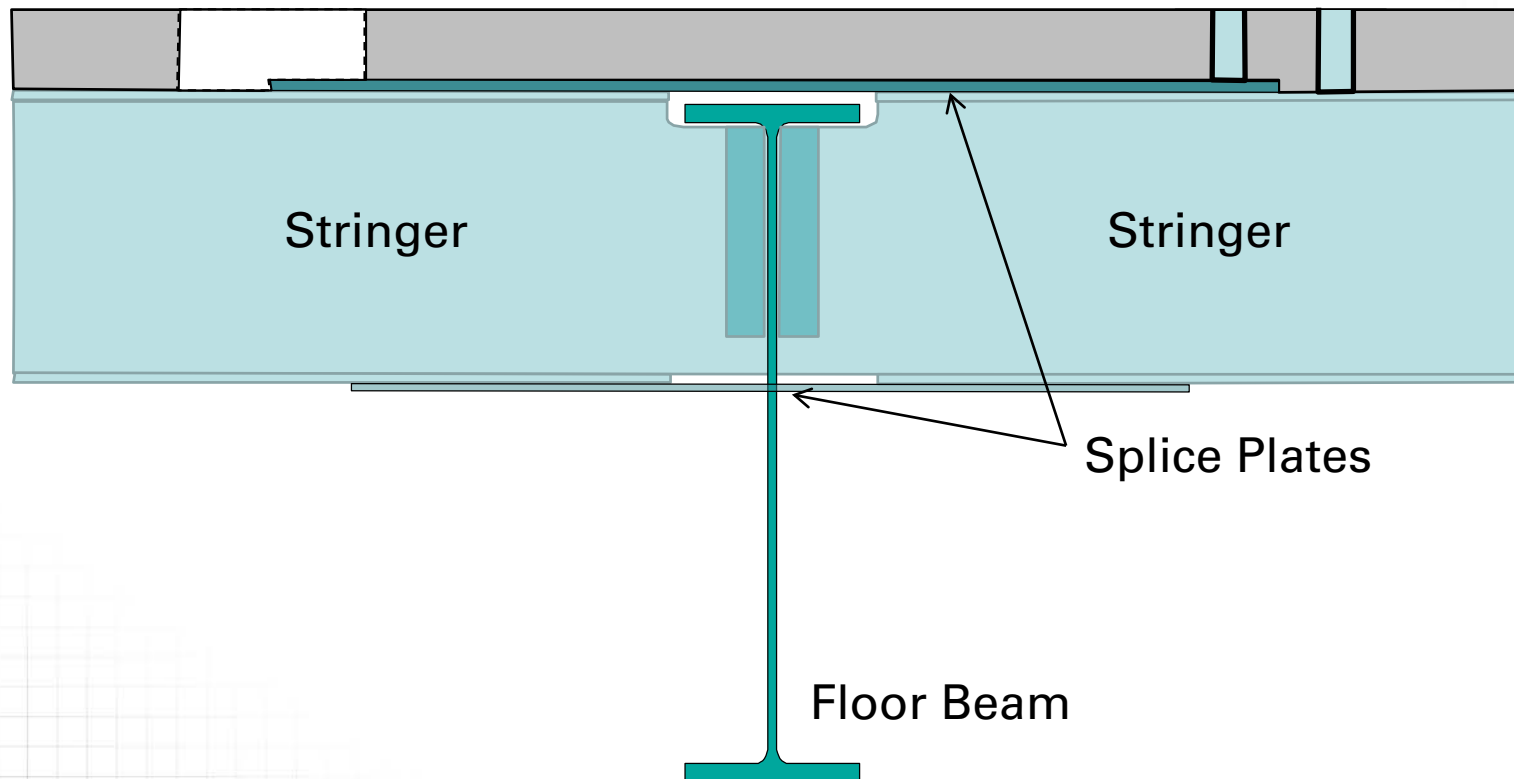
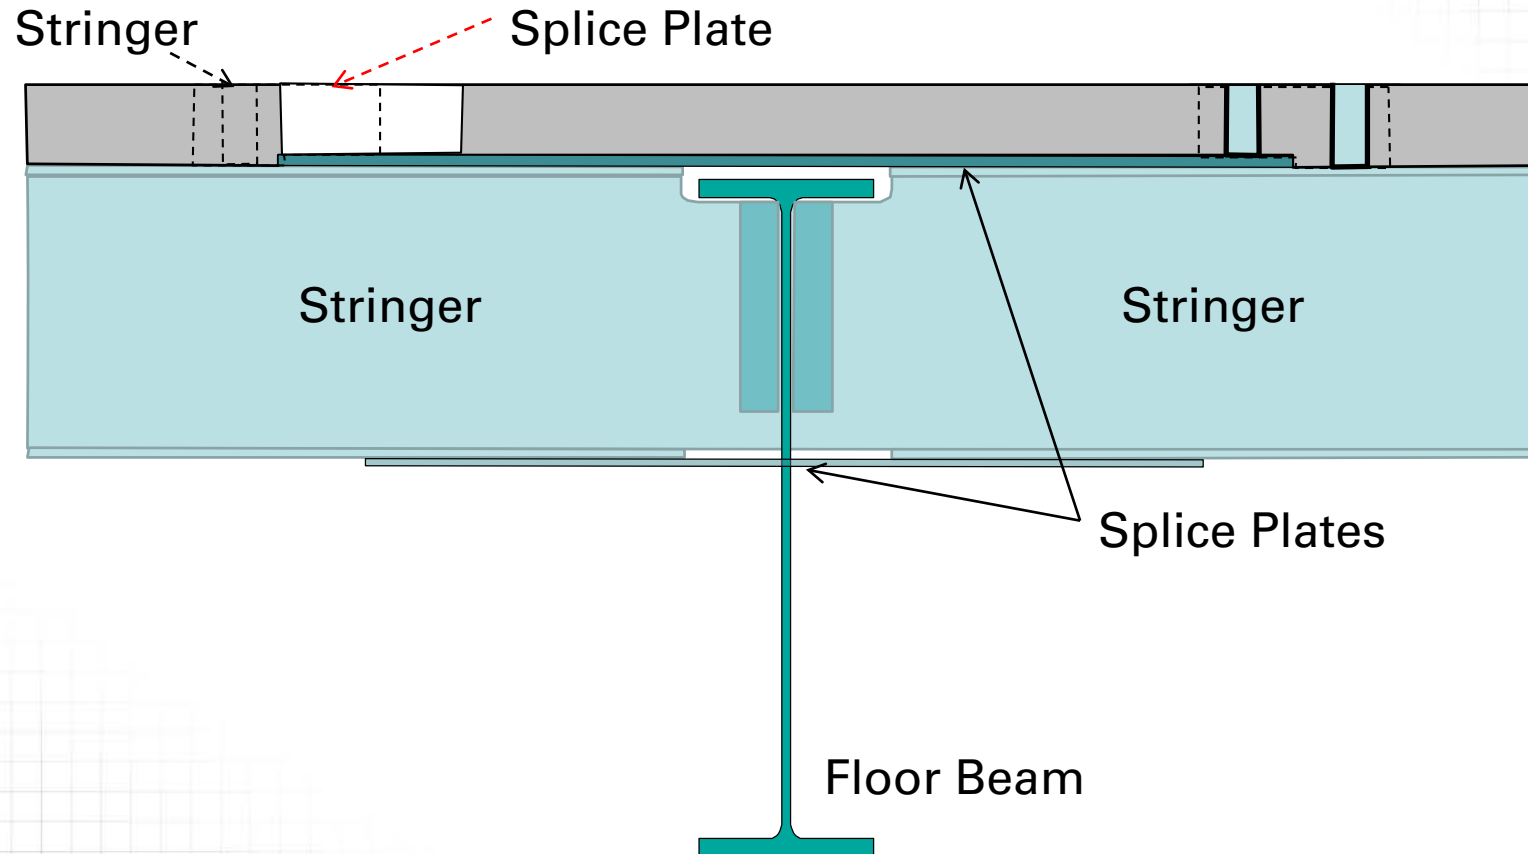
- Survey Pockets Construction **Errors**

- Problems with AB's initial survey
 - Survey Pocket Construction Errors:
 - Pockets constructed over splice plates
 - Pockets partially filled with concrete
 - Pockets installed at an angle (not plumb)
 - Survey Errors:
 - Control network
 - Backsights
 - Averaging of horizontal data
 - Failed to perform two vertical surveys

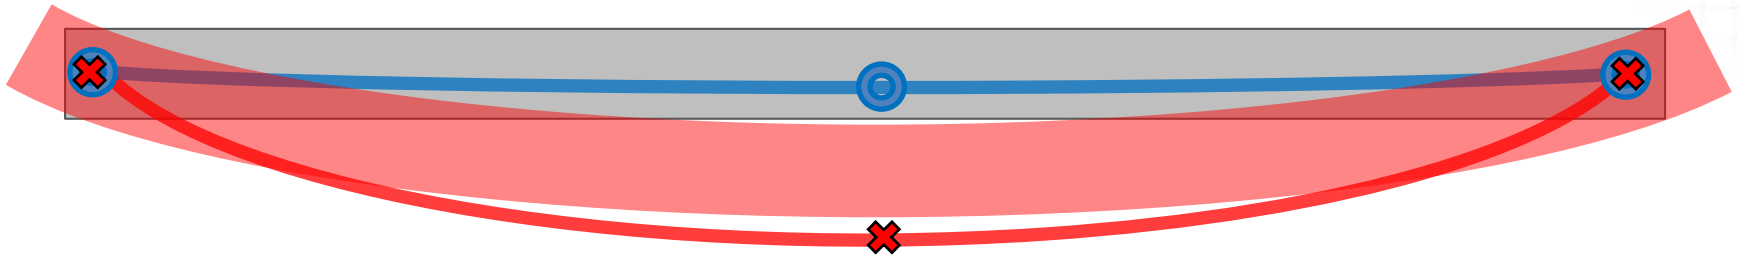
- Horizontal survey
 - Performed with a total station
 - Conducted two surveys
 - Results were averaged together to resolve discrepancies
 - Survey data **erroneously** created the appearance of significant horizontal sweeps in the stringer system

- Illustration

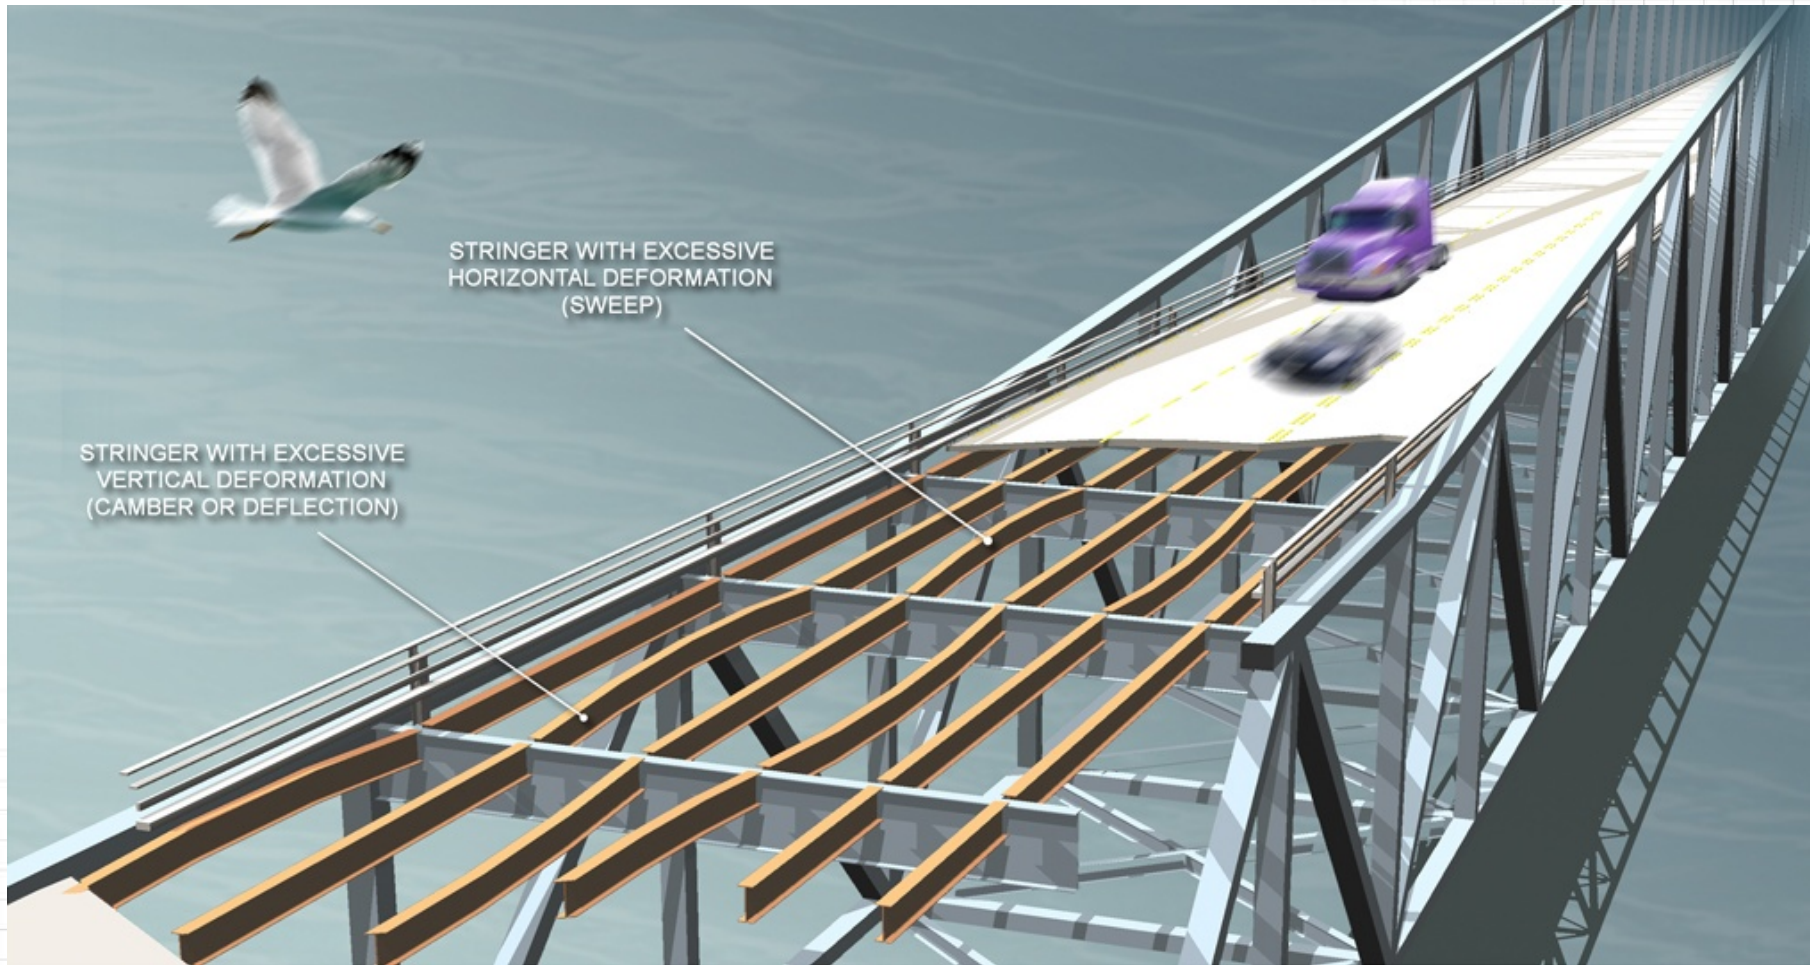
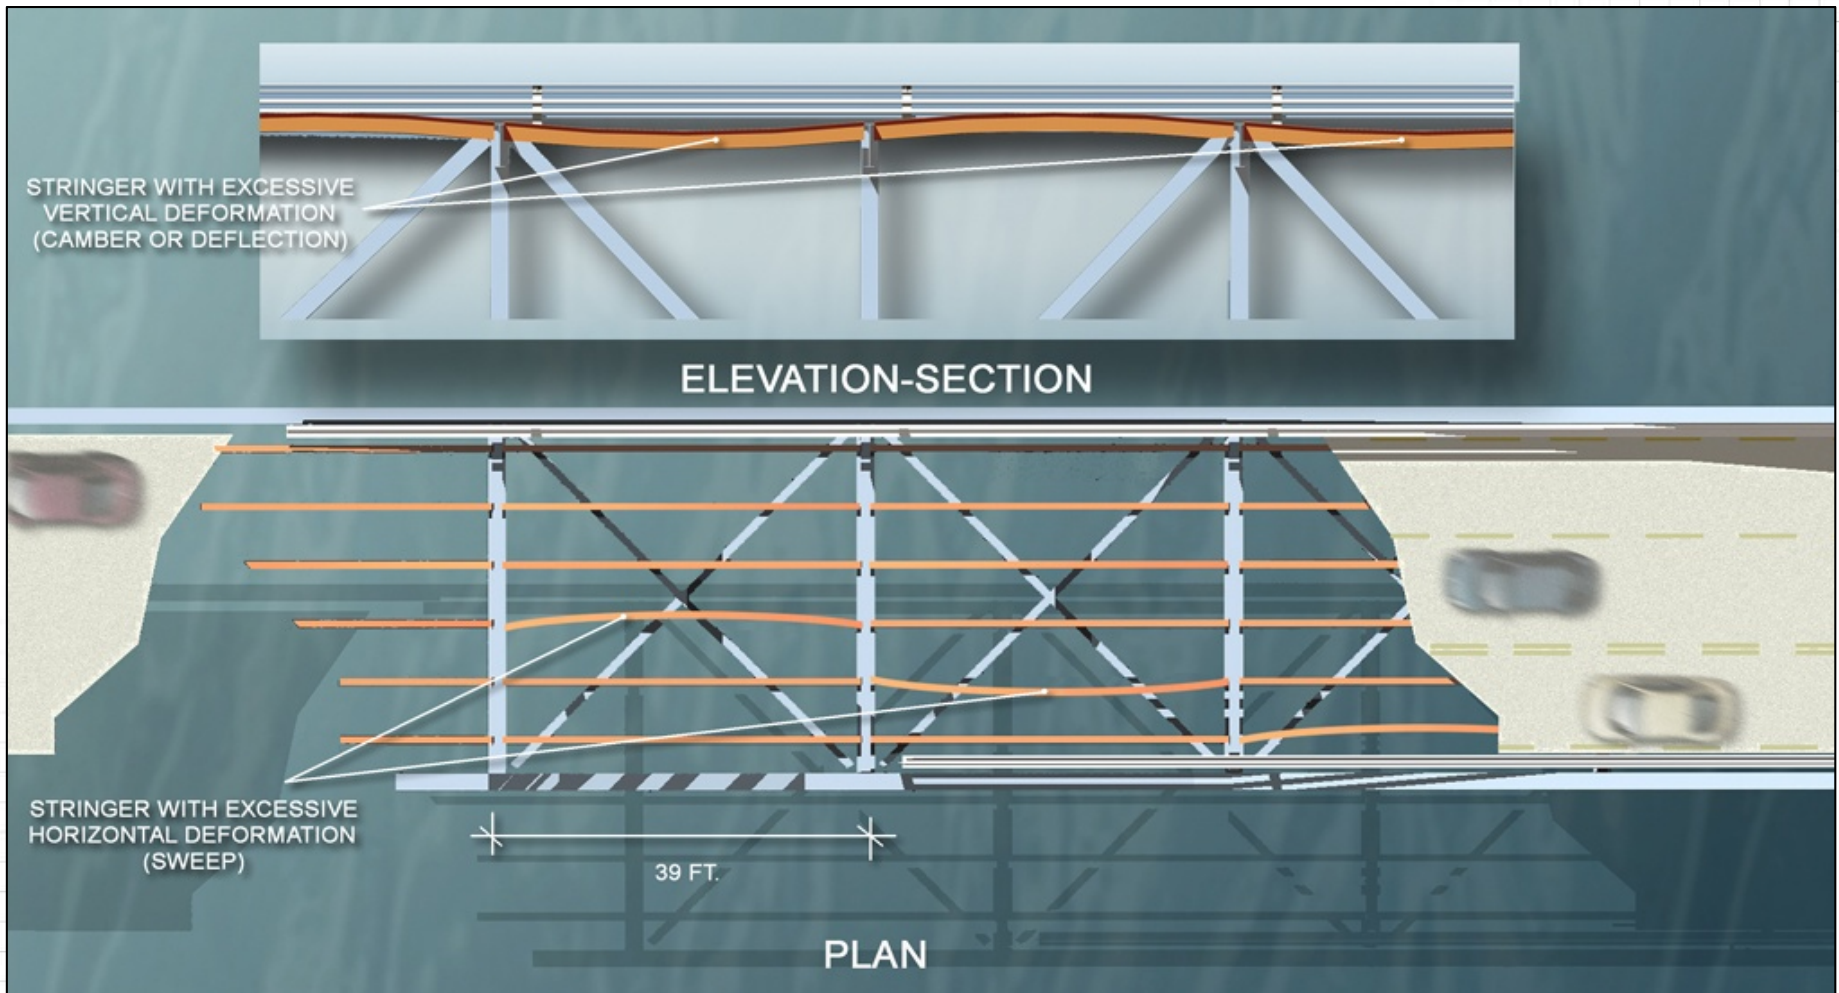
- Contractor says stringers are not straight vertically or horizontally
- Contractor alleges Differing Site Condition

- The data contained in the contractor's as-built survey indicated that numerous recesses would be needed in the pre-cast panels to accommodate the existing elevations of the stringers.
- A series of redline revisions were made to accommodate the data contained in the as-built survey.
- The contractor claimed that due to the differing site condition of the through truss steel, an additional cost of approximately \$59 million would be incurred in completing the project.

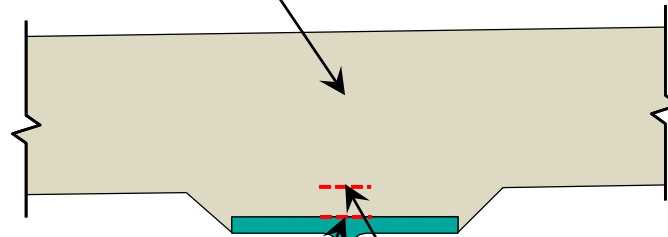
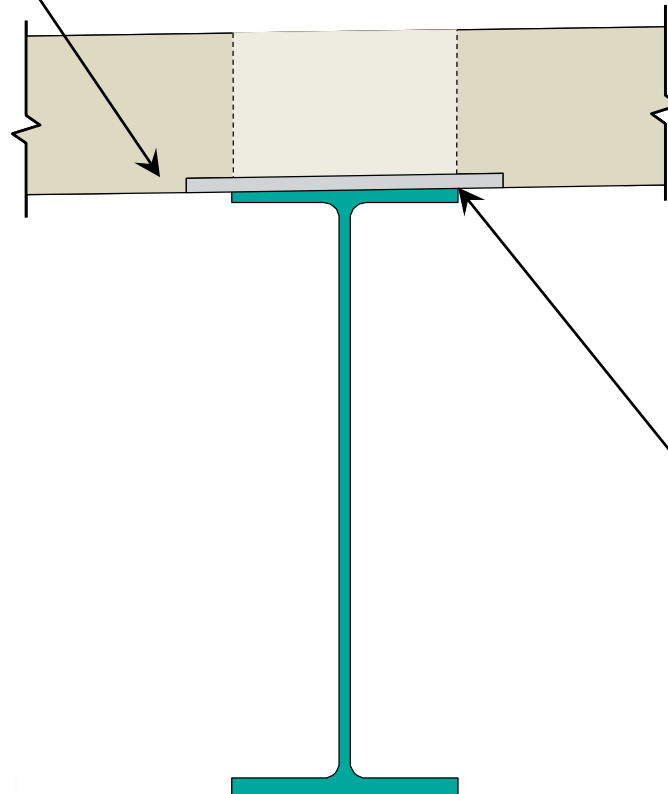
Existing Slab

Top of Stringer

AB top of Stringer Elevation

Required Recess

Inadequate shim
space

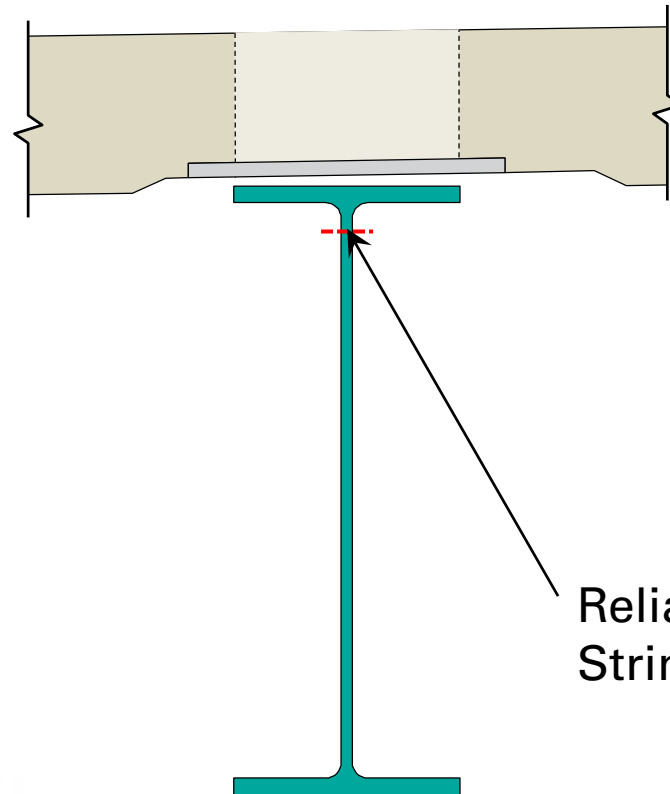
- MdTA's Survey Analysis (O'C&L)
 - Based on this discovery and the results of the resurvey MdTA directed Atlantic Bridge to conduct the second independent survey of the Through Truss Steel as required by the contract.
 - The results of the second survey conducted by the contractor were wholly consistent with the results of MdTA's survey and confirmed errors in AB's survey.
 - Further, the elevations from the resurvey indicated that, with minimal modification, the pre-cast deck could be constructed per plan.

Reliable Surveying top of
Stringer Elevation

- MdTA determined that the Contractor's initial survey was flawed due to construction and survey errors
- AB's second surveyor confirmed these errors
- AB's initial survey caused the unnecessary redesign and the subsequent delays to the project
- AB constructs panels per plan with minimal modifications
- MdTA denies AB's Differing Site Condition Claim and Change Order
